Division 3 Staff Meeting

March 2007

Safety & Health (Part 1)

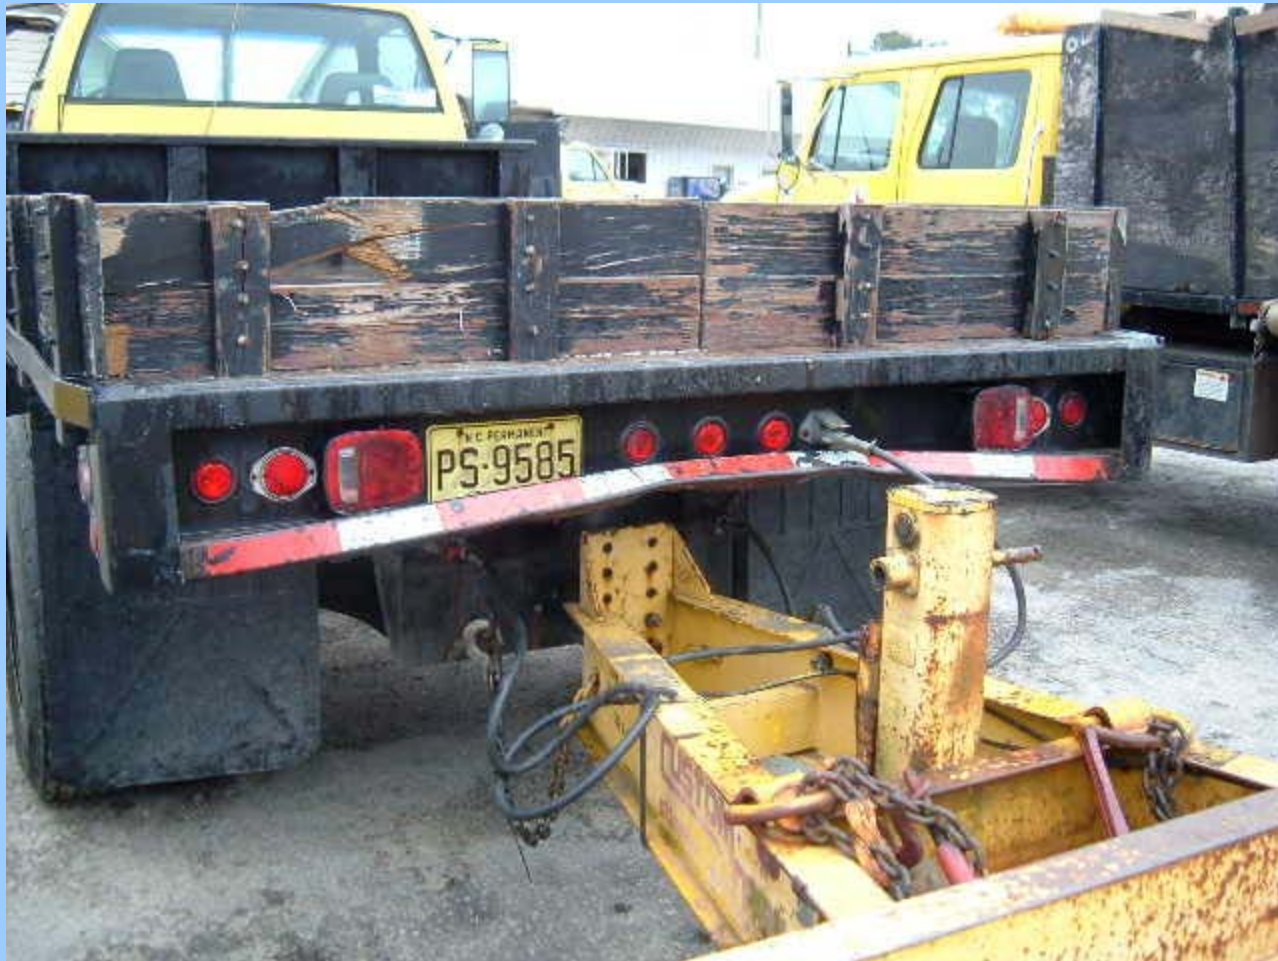
Latch on window of 1999 Case Backhoe came open during transit, causing window to break.

Root Cause: Window not latched properly.

- The driver towing the equipment is responsible for securing the load before transport.
- PST – Primary, Secondary and Tertiary checks on all vehicles. It is a TEAM effort – operator and driver need to check load prior to transport.**
